RE: Site Inspection, Torrey (AM Stone 110&101) Quarry, Star Stone Quarries, Inc., S/055/016, Wayne County, Utah

**Purpose of Inspection:** To perform an annual inspection of the project area.

# Torrey(AM Stone 100 & 101) M/055/016

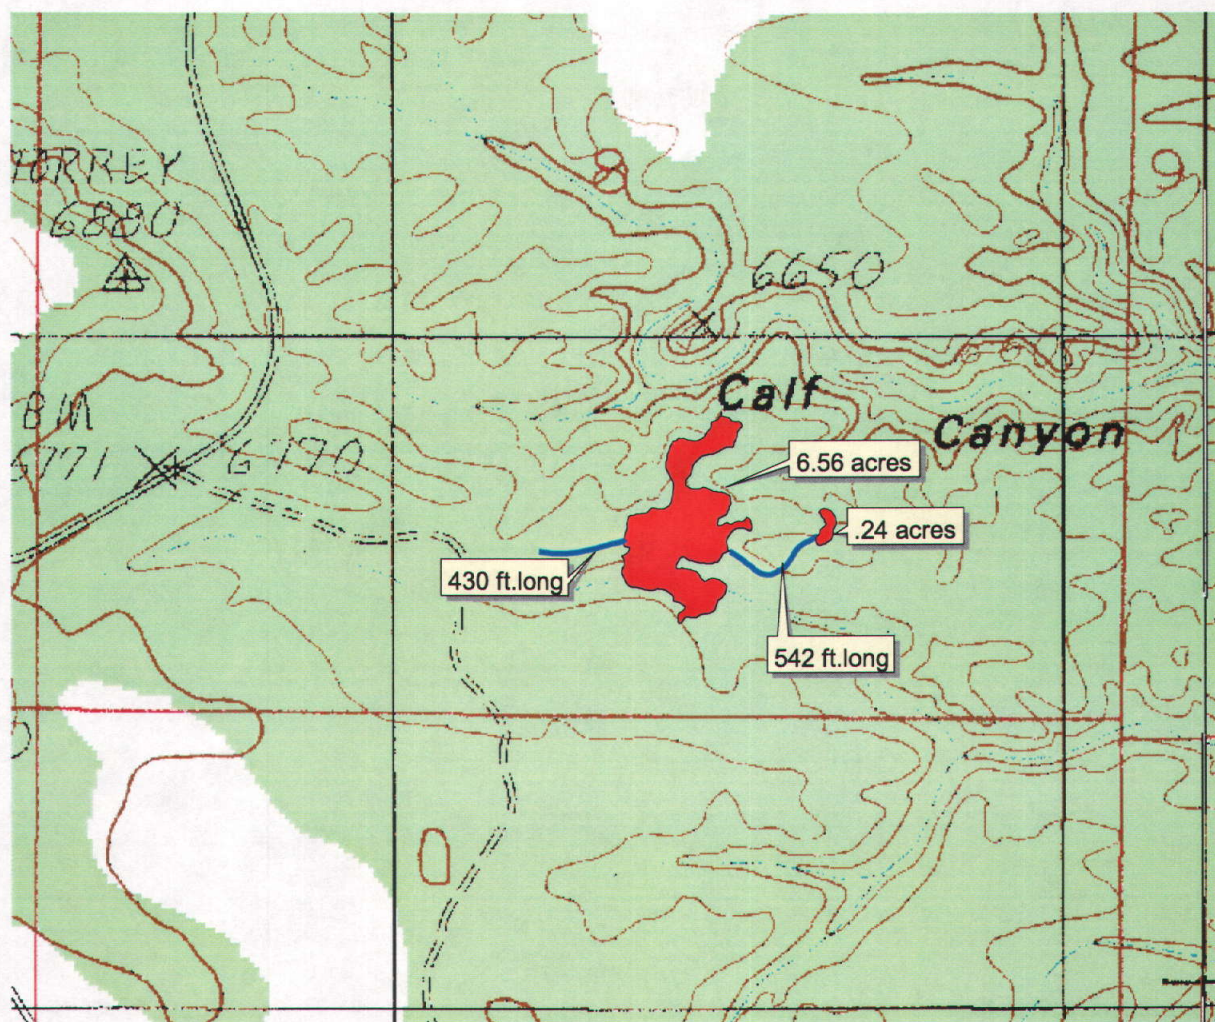
When I arrived onsite, it was noted that the site had been recently active; there was an assortment of trailers and mining/processing equipment that had been left on site. There was also a variety of palletted stone products on the site. I performed a GPS survey of the disturbances and determined the disturbed area to be in excess of five acres. Please refer to the attached GPS map and pictures documenting the mine site conditions at that time.

I found two areas of mining-related disturbance. The first area shown as 0.24 acres on the attached map was scraped clean of soil and was solid sandstone. Piles of salvaged soil material were stockpiled around the perimeter of this site disturbance. There was a short road approximately 542 feet long and 12 feet wide joining the adjacent 6.56 acre disturbance. The main disturbance consisted of a palletted stone stockpile area and associated mine excavations. Equipment found on site consisted of a trailer, a fuel truck, a water truck, a loader and a stone saw.

This overall site disturbance has been expanded to a large mine operational status. As such, the mining should be suspended until a transitional surety is filed with the Division and the disturbed area boundaries are physically marked. A large mine permit application should also be completed and filed with the Division as soon as possible.
